The 2016 Kumamoto Earthquakes: Cascading Geological Hazards and Compounding Risks

Keywords: 2016 Kumamoto earthquake, earthquake damage survey, surface rupture, ground deformation, ground motion, building damage, infrastructure damage

An earthquake damage investigation was conducted from May 22, 2016 to May 26, 2016. The main objective of the

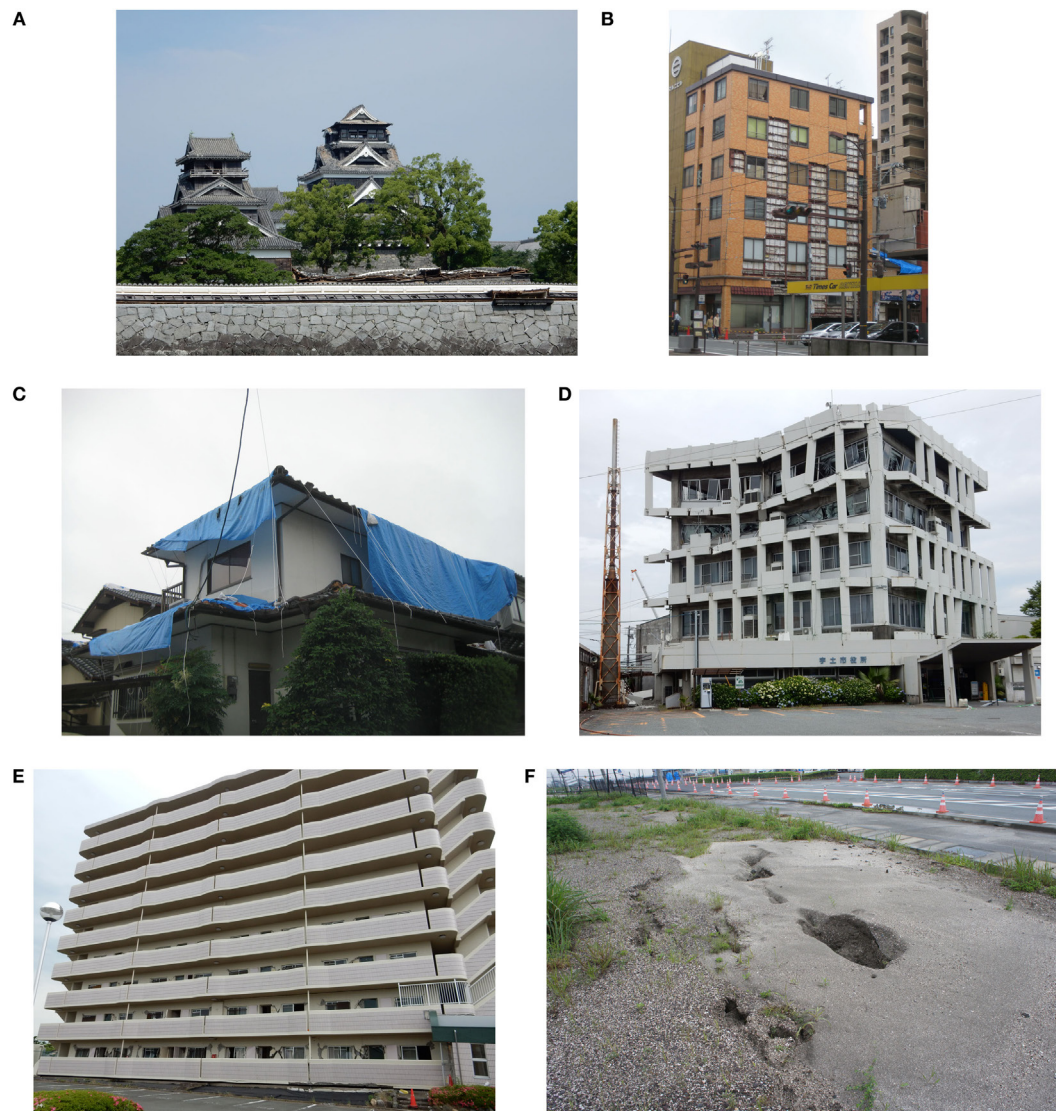
A damage survey was conducted near Kumamoto Castle (i.e., downtown Kumamoto City; Location 1 in **Figure 11A**). A photo of Kumamoto Castle is shown in **Figure 12A**. The roof of the main castle (right-hand side) was damaged, and the wooden panels on the stone walls had collapsed. In fact, wooden panels as well as stone walls had collapsed at several places around the castle. At one location, the collapsed stone walls fell over a temple, destroying it. Along the moat of the castle, cracks were observed on the side walk and minor lateral spreading was observed (some buildings tilted toward the moat). During the walk-around survey in the downtown

(near Kumamoto railway station and Kumamoto city office), damage to building cladding and external walls was observed (**Figure 12B**). Several high-rise buildings suffered earthquake damage, such as diagonal shear cracks that were visible from a distance. Although some old timber buildings suffered major damage and tilted (unrepairable damage), overall, major structural damage to modern buildings (timber/RC/steel) was neither major nor widespread, indicating that buildings in the city center performed well against the strong shaking experienced during the foreshock and mainshock.

In the south of KMM006 (Location 3 in Figure 11A), a 9-story RC apartment was damaged (Figure 12E); many diagonal shear cracks were observed on walls at the lower three floors. Along Akitsu river (near Location 3 in Figure 11A), ground deformation and failures, including liquefaction, were reported. Moreover, a field investigation was conducted at Kumamoto port (Location 4 in Figure 11A). The port was constructed on a man-made island. Since the opening of Kumamoto port in 1993, the port has served as an important access route for people and goods. Some damage to port facilities was observed (e.g., overpass steel bridge at the ferry terminal). After the Kumamoto mainshock, sand boils were observed at the port as the sand used for reclamation was liquefiable (Figure 12F; note: borehole data at a site in the port island indicated a 3-m thick sand layer near the ground surface). The estimated ground motion at Kumamoto port, based on statistical analysis of observed ground motions at recording stations, indicates that the experienced PGA (typically 0.5 g) at

FIGURE 12 | (A) Damage to Kumamoto castle (location 1 in region 1). **(B)** Cladding damage to a building in the city center (location 1 in region 1). **(C)** Roof damage near KMM006. **(D)** Damage to the Uto city office (location 2 in region 1; near KMM008). **(E)** Damage to a high-rise residential building (location 3 in region 1). **(F)** Liquefaction site at Kumamoto port (location 4 in region 1).

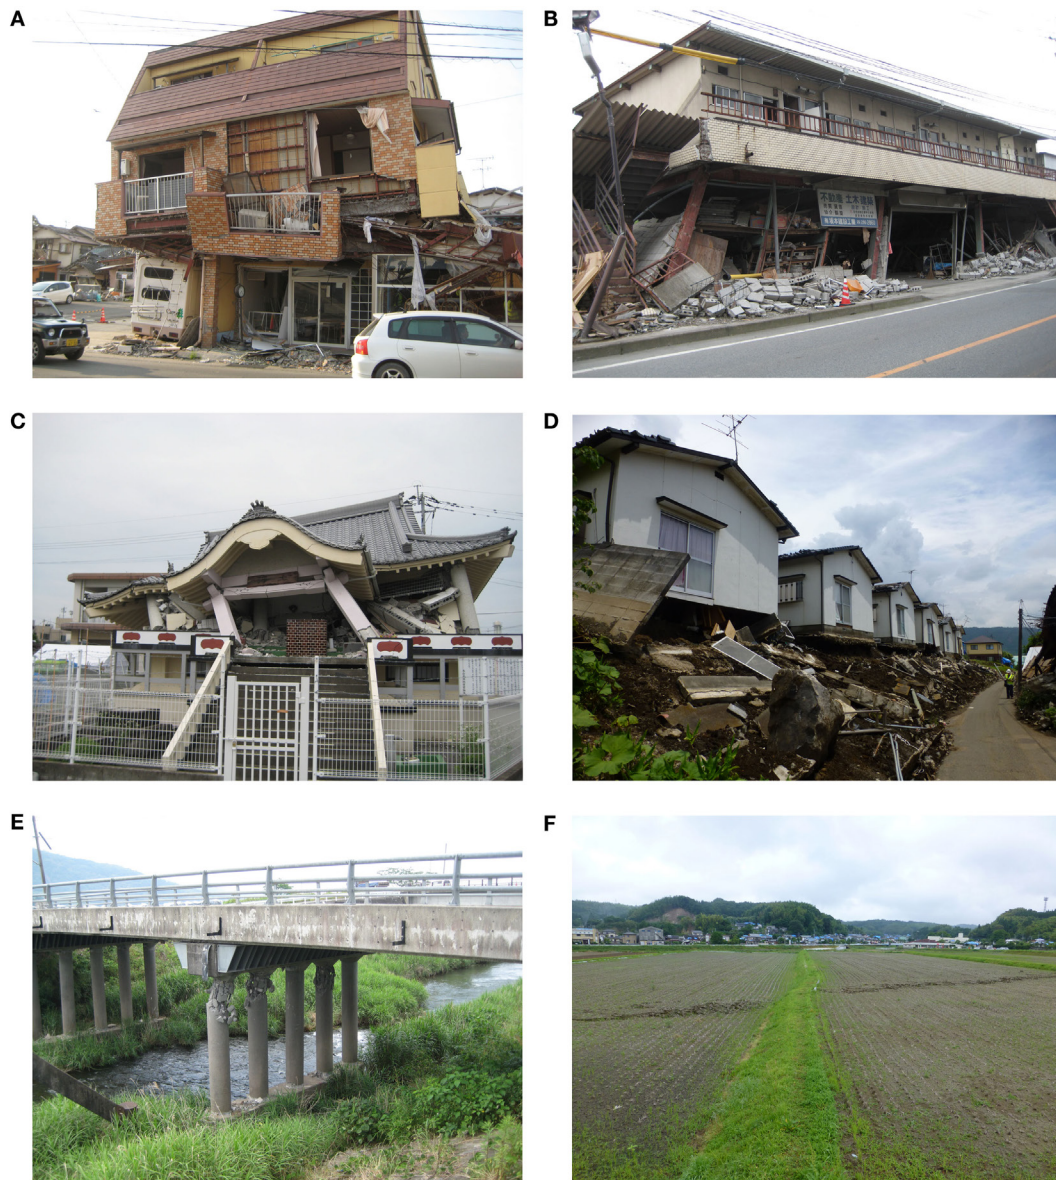
Along Road 28, many buildings were severely damaged or had collapsed. The building shown in Figure 13A was a four-story steel building; the second floor had completely collapsed in a soft-story collapse mechanism. The majority of the buildings that had suffered a soft-story collapse had predominantly deformed/collapsed in the EW direction (more toward west), approximately parallel with Road 28 (e.g., Figures 13A,B). This coincides with the major response axes of the ground motion experienced in Mashiki Town (Figure 8). It has been reported that the effects due to the double-shock ground motions in Mashiki Town were significant. For example, a two-story steel building (Figure 13B) suffered minor-to-moderate damage due to the foreshock; however, it was destroyed by the subsequent mainshock. Several steel as well as RC buildings also suffered extensive damage. For instance, a RC-frame temple (Figure 13C) had collapsed due to the failures of beam-column joints (note: this building did not

collapse after the foreshock but only suffered noticeable damage; it then collapsed due to the mainshock). Moreover, houses that were built on embankments suffered ground failures, and local soil conditions appear to be an important factor in the earthquake damage. For example, one row of six houses had collapsed partially due to foundation failures (**Figure 13D**). In the southern part of Mashiki Town (mainly agricultural areas along Kiyama river), uplifts of manholes were observed and settlements of the embankments along Kiyama river were seen (see also **Figure 15**), resulting in major gaps between the bridge deck and abutments. Typically, the bridge deck remained in its original position, while both sides of the embankments subsided by 0.4–0.5 m. RC piers of Daiichi Hatanaka bridge failed due to the ground deformation/failures (**Figure 13E**; Location 5 in **Figure 11B**; see also **Figure 15**). At the time of the survey, large sand bags (height of about 1 m) were placed along Kiyama river as temporary flood defenses. During the heavy rainfall on June 20 and 21, 2016 in Kumamoto, these temporary defenses were breached and Kiyama

The surface fault ruptures were observed in the paddy fields of Mashiki Town. **Figure 13F** shows the traces of the surface ruptures that appeared after the mainshock at Location 6 in **Figure 11B**. A clear misalignment of the ridge between paddy fields can be observed (circa 0.5–1.0 m, depending on the locations).

FIGURE 13 | (A) Collapsed steel building along Road 28 (location 5 in region 2). (B) Collapsed steel building along road 28 (location 5 in region 2). (C) Collapsed RC temple near the Mashiki town office (location 5 in region 2). (D) Building damage due to foundation failures (location 5 in region 2; near KMMH16). (E) Failures of RC piers of Daiichi Hatanaka bridge (location 5 in region 2). (F) Fault surface rupture (location 6 in region 2).

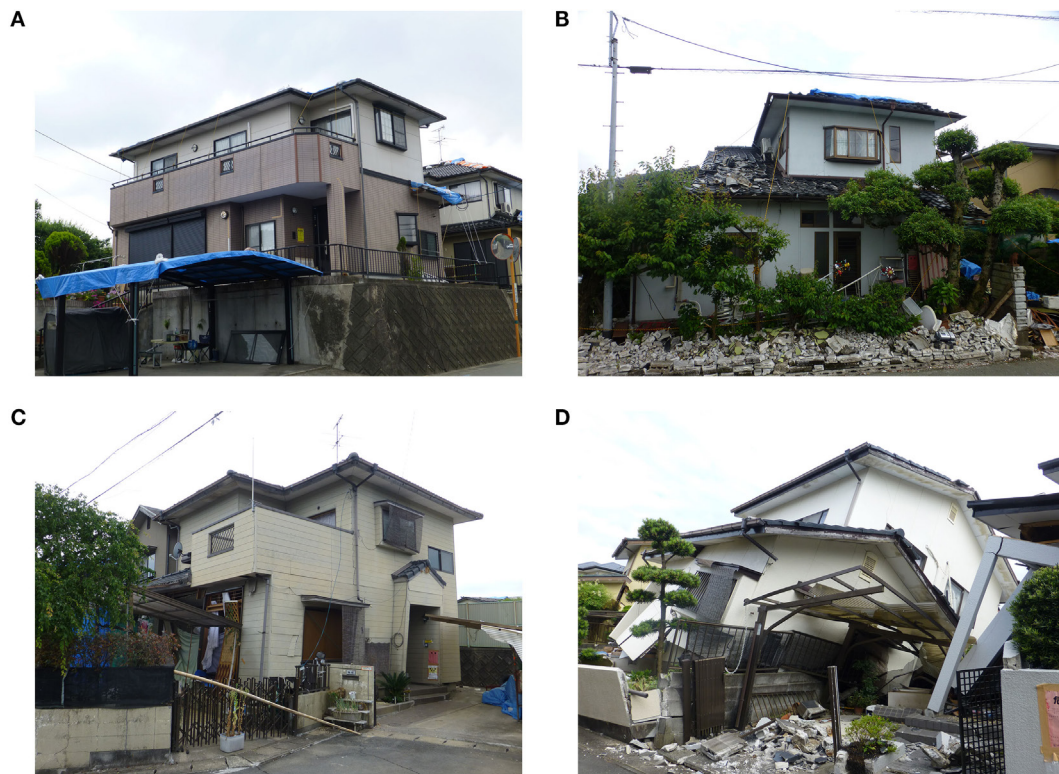
earthquake damage grade categories that are similar to the EMS-98 guideline (Grünthal, 1998). Typically, five damage severities were considered: no damage, slight damage, moderate damage, heavy damage, and destruction. **Figure 14** shows examples of building damage classifications from the survey. During the survey, material type (wood, RC, steel, and unknown), story number, and use/occupancy class (residential, commercial, public, and etc.) were recorded in addition to the damage severity.

FIGURE 14 | Examples of damaged and collapsed timber buildings in Mashiki Town: (A) slight damage, (B) moderate damage, (C) heavy damage, and (D) collapse.

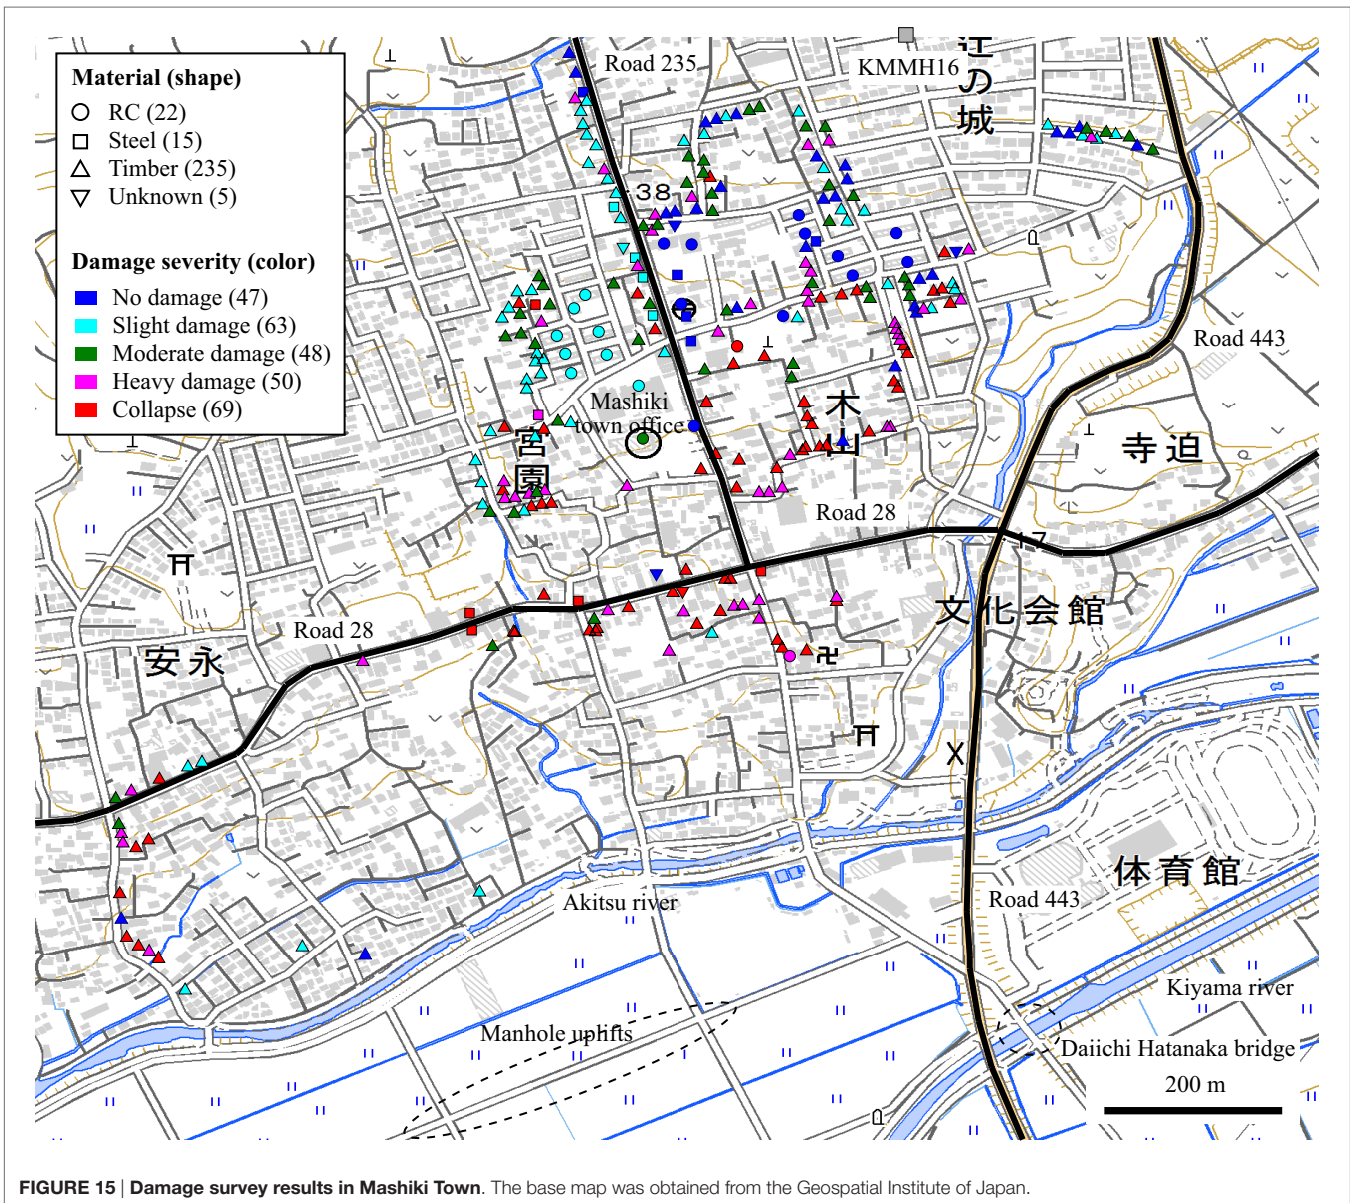
The results of the building damage survey in Mashiki Town are shown in **Figure 15**. In total, 277 buildings were inspected, consisting of 22 RC buildings, 15 steel buildings, 235 timber buildings, and 5 buildings with unknown material types. Out of 277 buildings, 47 buildings were undamaged, 63 buildings suffered slight damage, 50 buildings were heavily damaged, and

69 buildings were destroyed or are likely to be demolished due to unrepairable damage. Generally, newer timber houses as well as RC and steel buildings performed better than older timber houses. Houses in the south of the Mashiki town office were more severely damaged than those in the north, noting that the southern part of the surveyed areas was an older settlement. The differences of the damage extent in the northern and southern areas may also be attributed to geological conditions of the two areas (approximately, Road 28 is a boundary between the volcanic sediments and the river terrace deposits). Another important factor appeared to be the proximity to rivers (see **Figure 15**). Thus at the local scale, micro-zonation of soil types and geographical features may have been useful for evaluating seismic risk potential in this region *a priori*.

FIGURE 15 | Damage survey results in Mashiki Town. The base map was obtained from the Geospatial Institute of Japan.

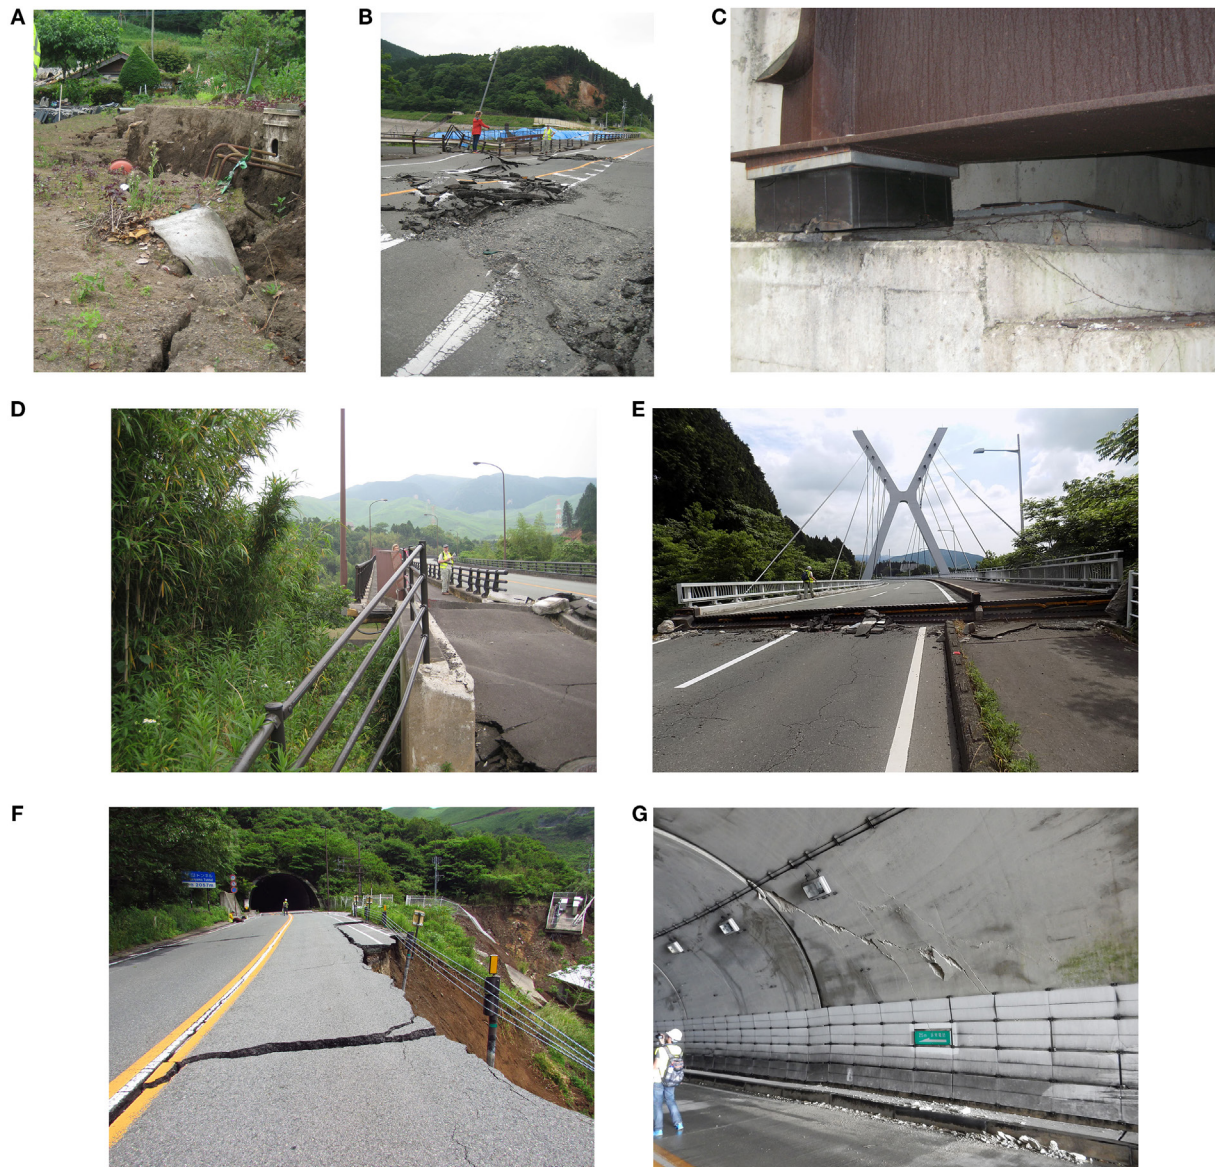
A fault deformation and surface rupture in Nishihara Village were investigated at Location 7 in **Figure 11B**. The fault rupture cut across the ridge of a hill. At the surveyed location (a farmer's house and field), a vertical deformation up to 0.6 m was observed (**Figure 16A**). Buildings in the property suffered major damage or collapse; a timber structure (barn/storage) that was directly above

The major damage was observed near the Oogiribata reservoir (Location 8 in **Figure 11B**), which was essentially located directly above the Futagawa fault. The 23 m high earth-fill Oogiribata dam constructed in 1975 has been utilized for irrigation as well as fire-fighting purposes, and has played an important role in local communities. At the crest of Oogiribata dam, major surface rupture was observed (**Figure 16B**). The road pavements were destroyed due to compressional forces. The retaining walls of the spillway were damaged and were tilted significantly. Due to damage to the control gate for releasing water, a large volume of the stored water had leaked accidentally after the mainshock; no fatalities/casualties were reported to have been caused due to this damage.

In the same area, Oogiribata bridge, a curved 5-span steel girder bridge constructed in 2000, was damaged significantly. The bridge was constructed to bypass a valley, where a major landslide occurred along the slope; the slipped soils might have affected the bridge piers at their base. Large cracks and gaps were observed at both sides of the abutments/roads. At the upper side of the bridge, all five bridge supports, i.e., laminated rubber bearing, had sheared/ruptured completely (**Figure 16C**). Consequently, the bridge deck was dismantled and displaced by about 0.3–0.4 m toward the valley side of the slope (**Figure 16D**).

FIGURE 16 | (A) Fault surface rupture in Mashiki Town (location 7 in region 2). **(B)** Fault surface rupture at the crest of Oogiribata dam (location 8 in region 2). **(C)** Shear fracture of bridge support underneath Oogiribata bridge (location 8 in region 2). **(D)** Damage to Oogiribata bridge (location 8 in region 2). **(E)** Damage to Kuwatsuru bridge (location 9 in region 2). **(F)** Road failure near Tawarayama tunnel (location 10 in region 2). **(G)** Cracks inside Tawarayama tunnel (location 10 in region 2).

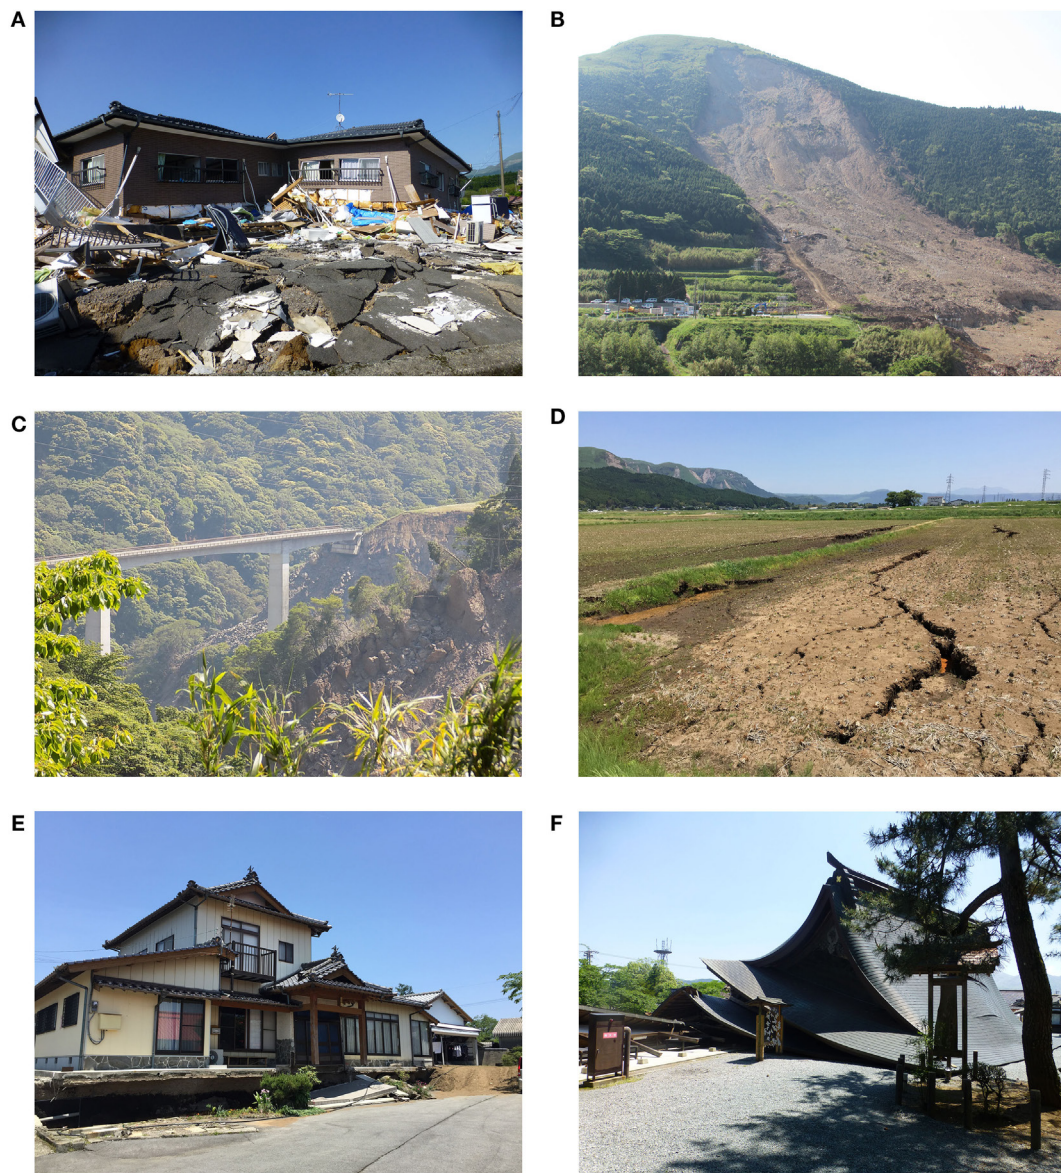
(**Figure 17B**; approximately, 700 m long and 200 m wide), which destroyed Route 57, which connected Kumamoto Prefecture and Oita Prefecture *via* Aso Caldera. The landslide caused the collapse of Aso bridge (Location 11 in **Figure 11C**). Aso bridge was a steel reversed Langer bridge constructed in 1970 crossing over Kurokawa river, and was a part of the regional road network, connecting the Tateno district and the Kurokawa district of Minami Aso Village (i.e., outside and inside of Aso Caldera). It is important to recognize that the Futagawa fault cut underneath of Aso bridge; henceforth, differential ground deformations at both sides of the bridge could have been significant (because of the strike-slip faulting and the locations are very near to the fault strike; see **Figure 4**). The collapse of Aso bridge may be due to the combined effects of the ground deformation and the landslide. More investigations are warranted regarding the exact cause of the bridge collapse.

The earthquake damage surveys were also carried out in Aso City, NE of the fault rupture zone. Near the Akamizu railway station (Location 12 in **Figure 11C**), ground failures were observed in the paddy field (**Figure 17D**); about 0.7 m

FIGURE 17 | (A) Collapsed timber building in the Kurokawa district of Minami Aso Village (Location 11 in Region 3). **(B)** Route 57 blockage due to the landslide near Aso bridge (location 11 in Region 3). **(C)** Damage to Choyo bridge (location 11 in Region 3). **(D)** Ground cracks near the Akamizu railway station (location 12 in region 3). **(E)** Ground settlement over a timber house (location 13 in region 3). **(F)** Collapse of Aso Shrine (location 14 in region 3).

subsidence of the ground was observed. The direct cause of the subsidence is not yet known because the location is relatively distant from the fault rupture zone. Similar ground settlements were observed along Road 175 (Location 13 in **Figure 11C**). Subsidence of about 1.0–1.5 m was observed, depending on the locations. Houses directly above the ground cracks had been destroyed (**Figure 17E**), while houses on the subsided portion of the ground were intact (no viable damage externally). These ground failures were localized.

designated as important cultural properties of the nation. The main structures of Aso Shrine had been destroyed by the mainshock (**Figure 17F**). On the other hand, in the surrounding areas of Aso Shrine, no obvious ground failures were observed. Because large long-period ground motions were recorded at the KMM004 station (**Figure 8**) and roof structures were heavy, the main cause of the collapse of Aso Shrine may be attributed to the shaking. Nonetheless, more investigations are warranted to understand the exact cause of the exceptionally large ground motions in these areas, which are remote from the fault rupture zone.

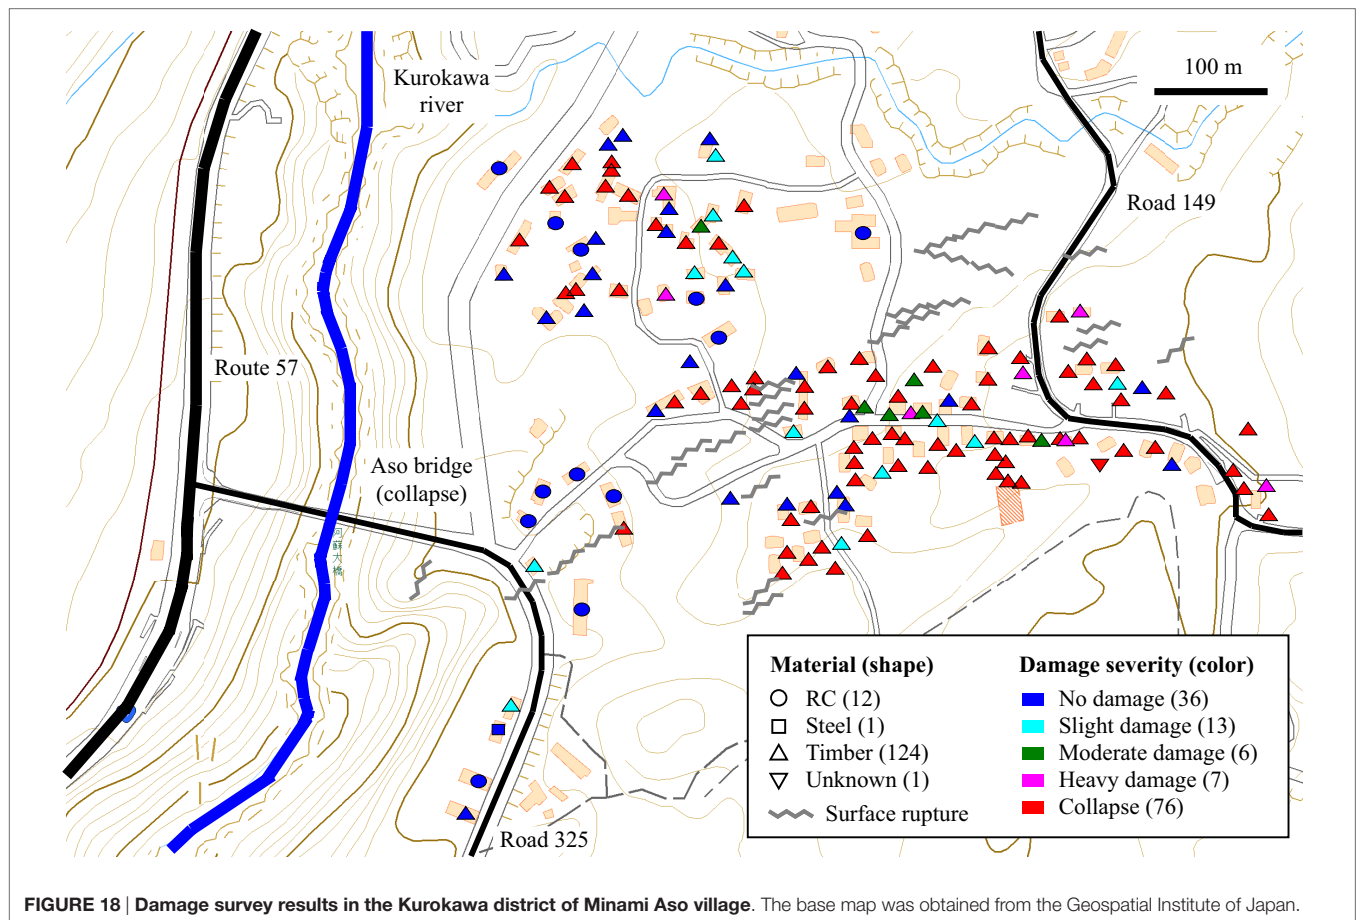
University group. The results are presented in **Figure 18** (the format is similar to those shown in **Figure 15** for Mashiki Town). In total, 138 buildings were inspected; the majority of the surveyed structures were residential timber houses, while RC buildings were an elementary school and apartment buildings. **Figure 18** shows that more than a half of the timber houses had collapsed due to the mainshock. On the other hand, larger RC structures were not damaged. To examine the correlation between observed surface ruptures and building damage, videos taken from a UAV (unmanned aerial vehicle) that were provided by the GSI were analyzed. The identified surface ruptures in the Kurokawa district are indicated in **Figure 18**. It can be observed that some of the surface ruptures cut underneath buildings, which were destroyed.

FIGURE 18 | Damage survey results in the Kurokawa district of Minami Aso village. The base map was obtained from the Geospatial Institute of Japan.
